Audit Service Sierra Leone

PERFORMANCE AUDIT REPORT ON THE SUPPLY OF POTABLE WATER BY SALWACO

SEPTEMBER, 2012

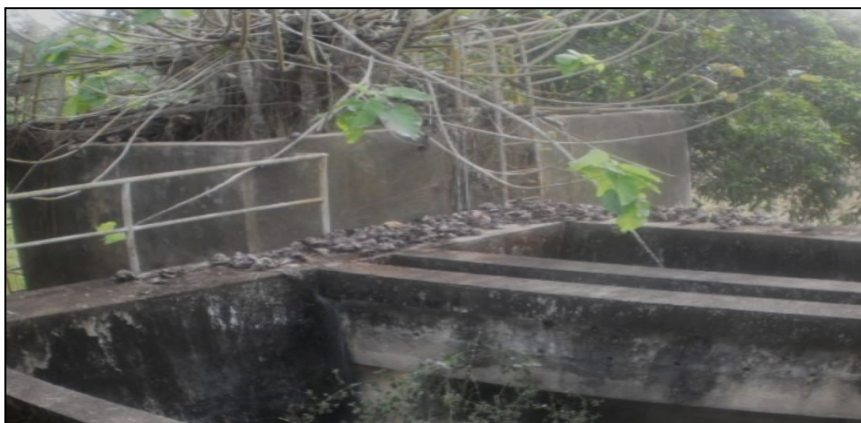
It was observed that after the Degremont plant broke down in 1983 it had never been rehabilitated, repaired or maintained. According to the network supervisor the treatment plant, if not for its dysfunctional state, would have been able to efficiently and effectively supply sufficient potable water to the entire city.

A view of the defunct Water Treatment Plant, Kenema

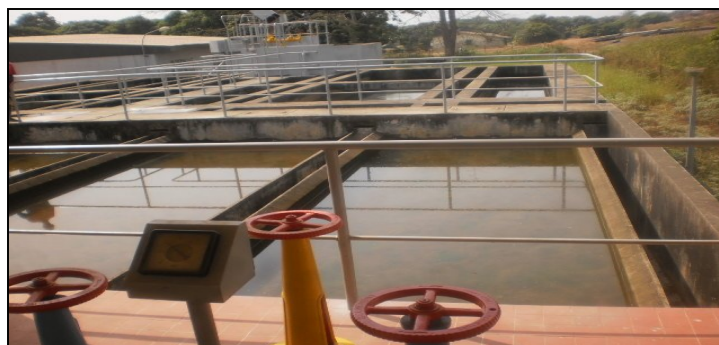
Rehabilitated treatment plant - Make
