**PERFORMANCE
AUDIT REPORT**

**ON THE
DISTRIBUTION**

**SUPPLY IN THE
WESTERN AREA**

BY THE GUMA

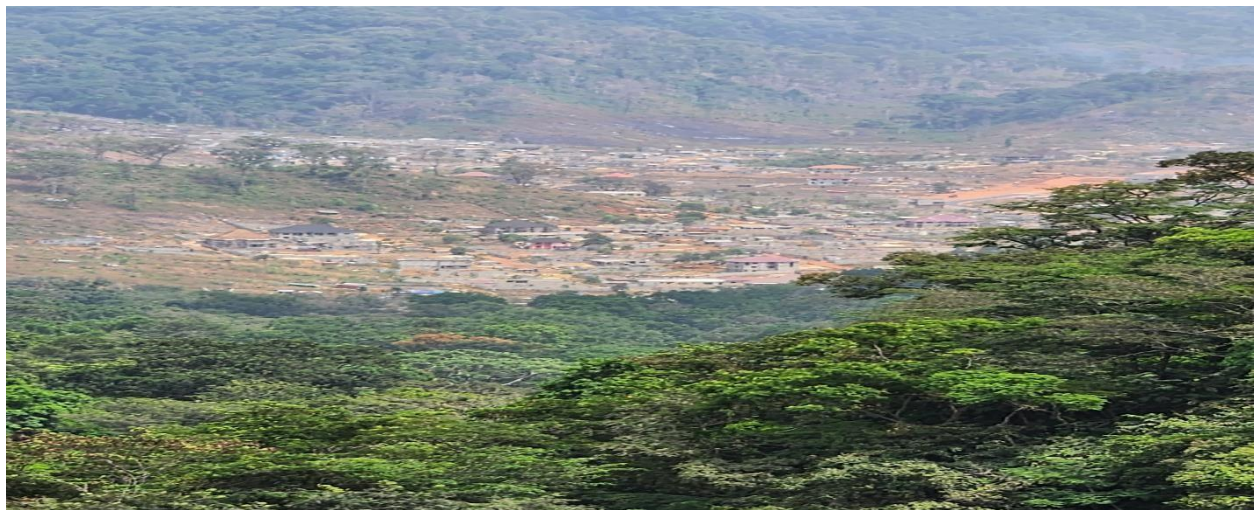
Illegal logging has had a huge impact on climate change that will make it almost impossible for the GVWC to provide potable water in the near future. Despite the legal framework in place to protect the reserve, unregulated human activities have not stopped people from invading these catchment areas.

Photo 1: Showing massive encroachment at the GVWC catchment area at mile 13. Photo taken by the audit team on 23rd March, 2023.

The Managing Director in collaboration with other stakeholders including the Ministry of Environment, the Ministry of Lands and the EPA should ensure the enforcement of regulations and other measures to discourage encroachment and protect catchment areas in order to prevent water shortage and climate hazards.
